# HP LTO Ultrium tape drives technical reference manual

## LTO4 FC, SCSI and SAS drives volume 1: hardware integration

Edition 2, August 2007

Part number: EH851-90901 volume 1

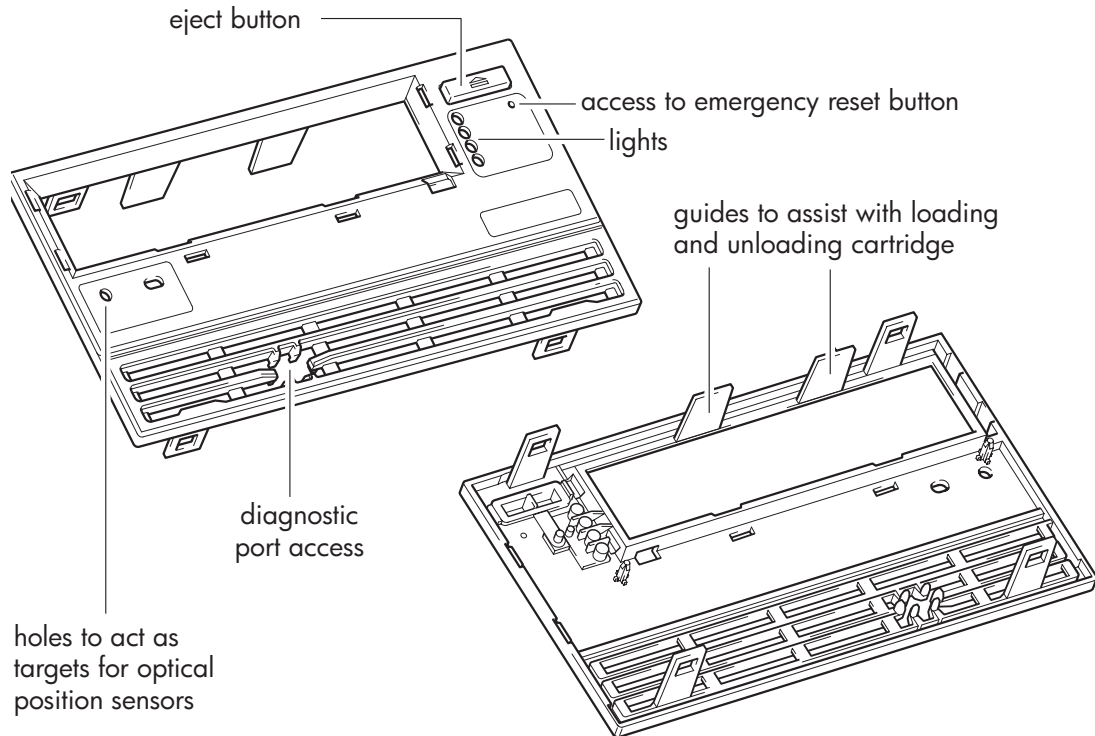
## Front panel for automation use

The automation front panel has the following features:

- There is an eject button for manually ejecting a cartridge. Press this for approximately ten seconds to start a “forced eject” for recovering a cartridge manually. See [page 22](#) for details.

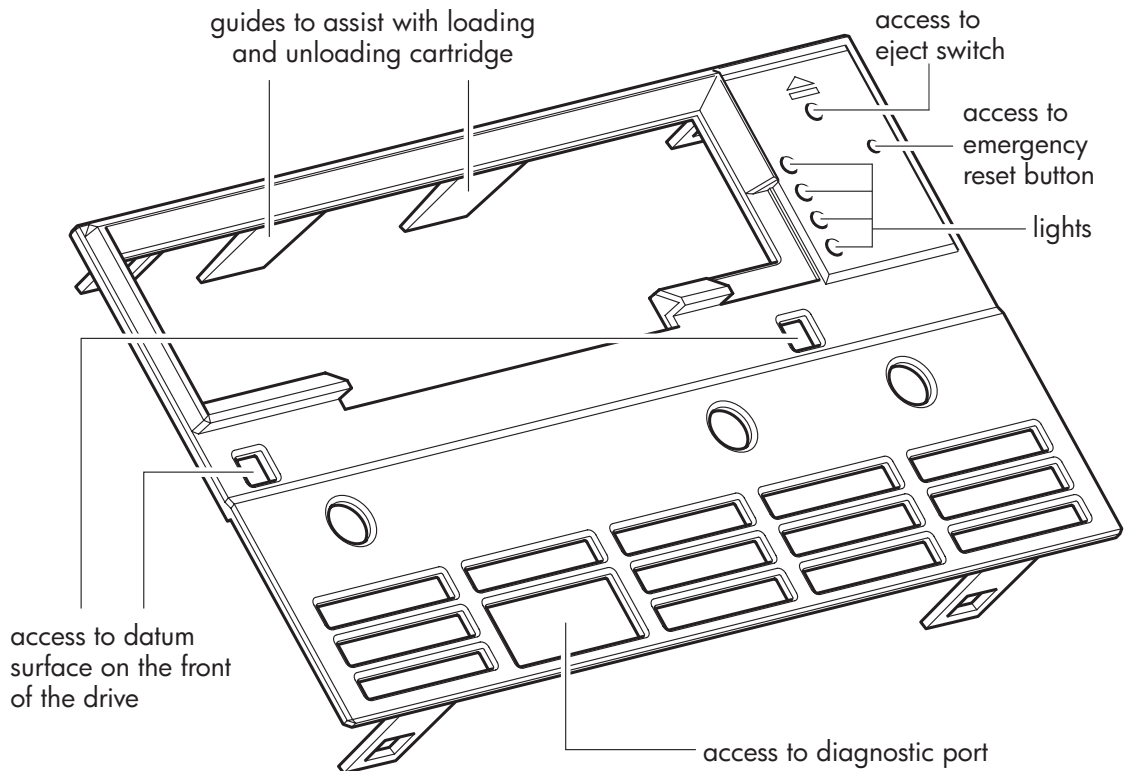
A special front panel is available for autoloader applications where the autoloader conforms to a 2U product height. The front panel fits within the drive form factor in height and width:

The autoloader front panel has the following features:

- Simple one-piece plastic design
- Pinhole access to the eject switch on the drive for manually ejecting a cartridge. Press this for approximately ten seconds to start a "forced eject" for recovering a cartridge manually. See [page 22](#) for details.

- Indicator LEDs provide a visible indicator of the state of health of the drive. See [Chapter 6](#) for details. The LEDs are viewed through holes in the autoloader front panel; no light pipes are present.

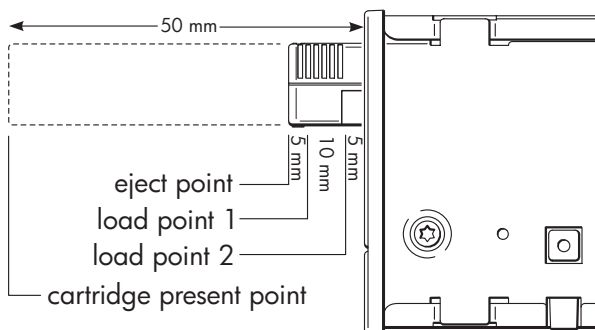
## Full-height drives

The following diagrams show the positions of importance during load and unload.

### Eject Point

Cartridges are ejected to this point. It is 20.9 mm beyond the front panel and 26.1 mm beyond the front of the mechanism. The position tolerance is  $\pm 1$  mm. The automation controller cannot configure the location of this position.

Load Point 1 is the recommended minimum load point for commanded loads. It is 15 mm beyond the front panel with a  $-2$  mm tolerance.

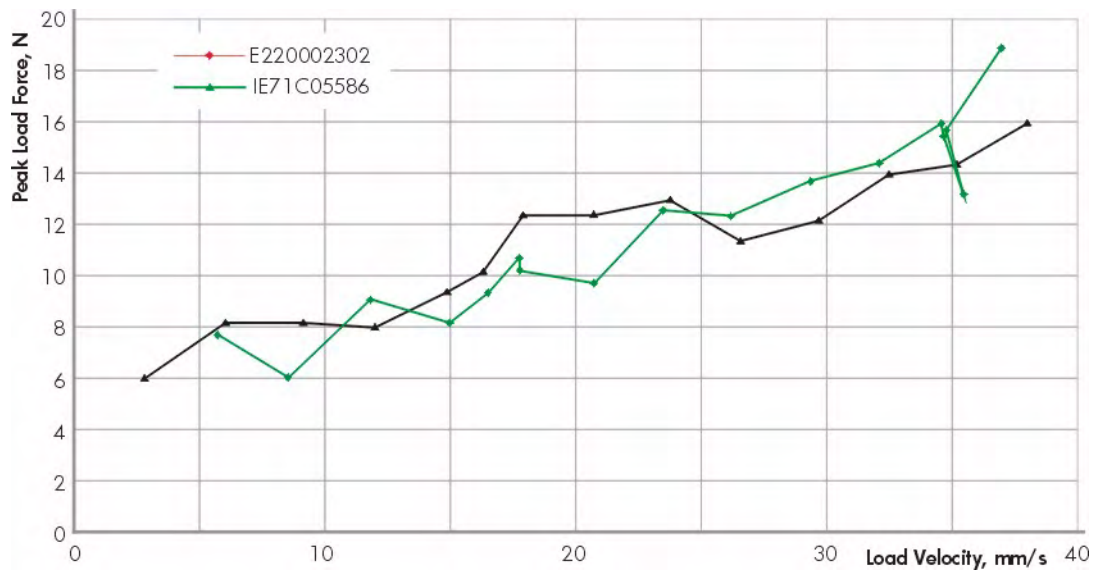
**Figure 1** Peak load force versus load speed

The *load* force varies according to the speed at which the cartridge is inserted into the drive. The peak load force occurs when the cartridge begins to accelerate the drive carrier and only lasts for a short time. The following graph plots examples of peak load force against load speed:

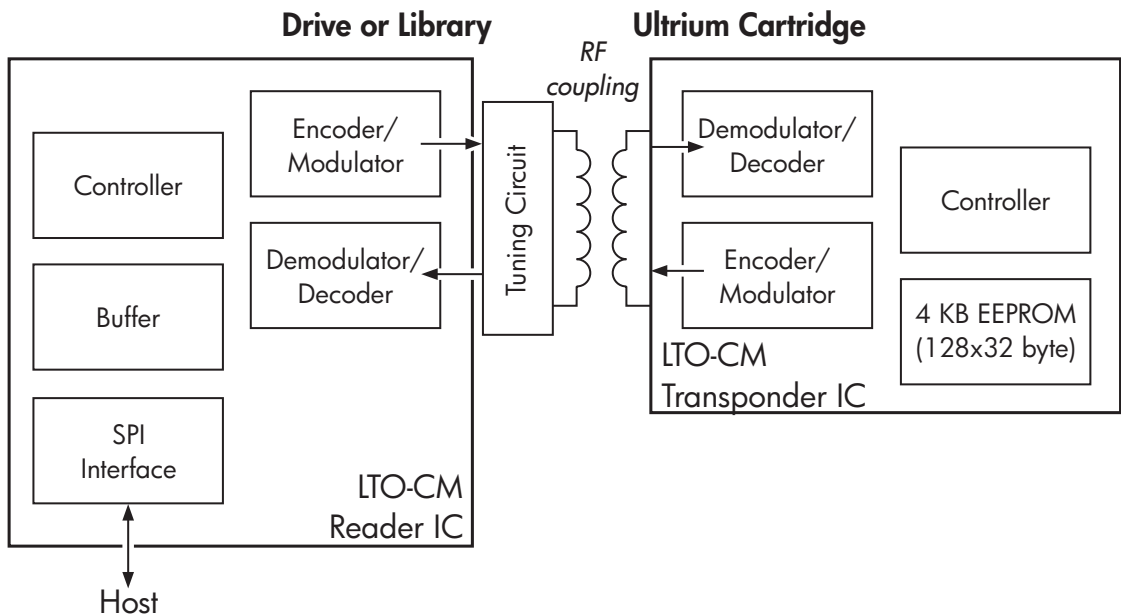
Cartridge memory offers possibilities for use in libraries as an adjunct to or replacement for barcodes. The following diagram shows the architecture required. HP is working to provide a standard module with this functionality via a third party.

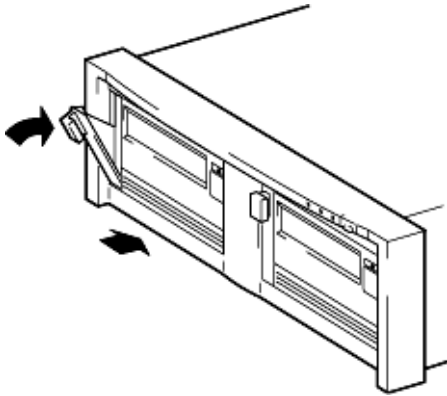
## Inserting a drive

1. Ensure that the extractor lever on the drive is in the out position, as shown in the picture.
2. Lift the drive carefully.
3. Align the rear of the drive with the guides on the side of the HP StorageWorks Tape Array 5300.
4. Slide the drive along the guides until the connectors on the back mate with the connectors at the back of the enclosure.
5. Push the extractor lever in until it locks the drive in position.

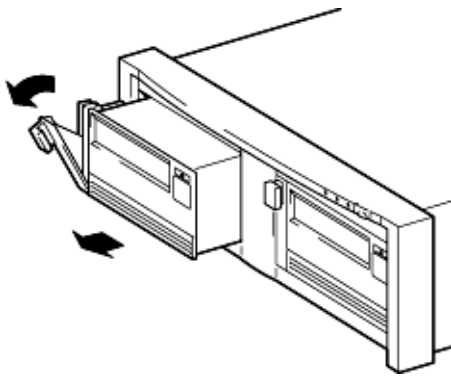
## Removing a drive

1. Pull the extraction lever of the drive that you want to replace so that it is in the out position.
2. Using the extraction lever, pull the drive gently and firmly out of the tape array.

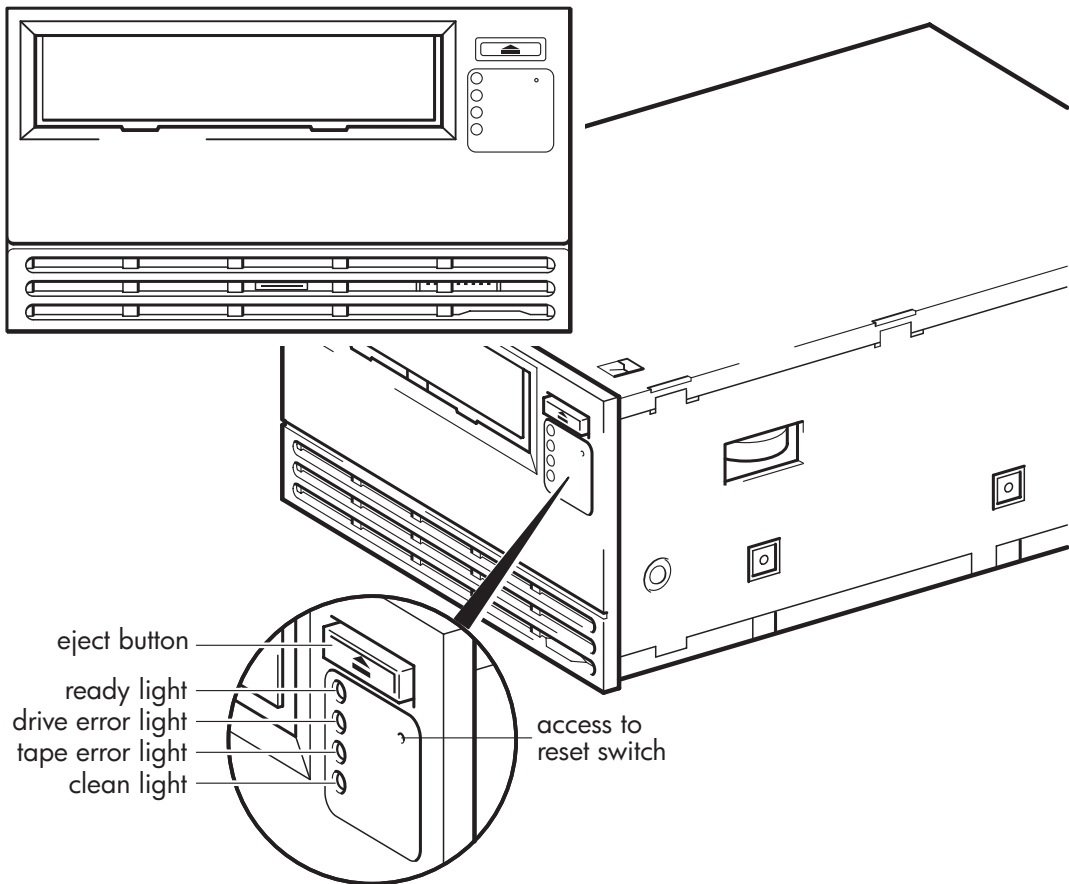
## Front panel features

The emergency reset switch allows you to reset the drive without powering off the drive and computer, for example if the drive stops responding. Access to the switch is through a small hole. It can be activated by a thin object, such as the end of a straightened paper-clip.

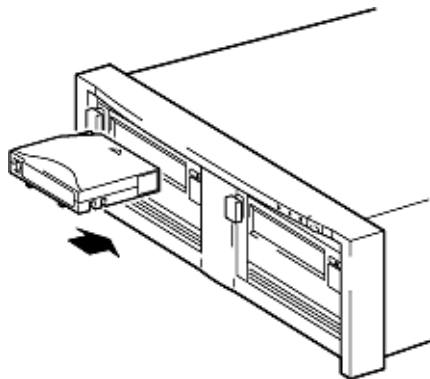
## Loading a cartridge

Use HP LTO Ultrium cartridges with your drive.

Do not try to force the cartridge if it does not load properly. The drive will eject the cartridge after about 10 seconds so you can load it again.

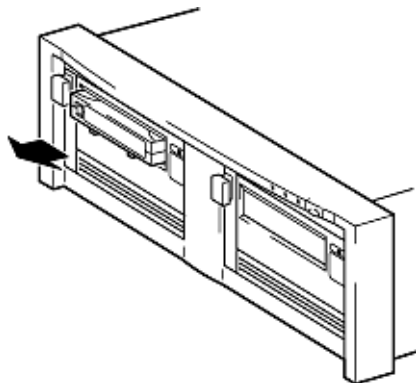
## Unloading a cartridge

### 1. Press the Eject button on the front panel.

During the unload sequence the 'Ready' LED flashes green. The drive completes any task it is

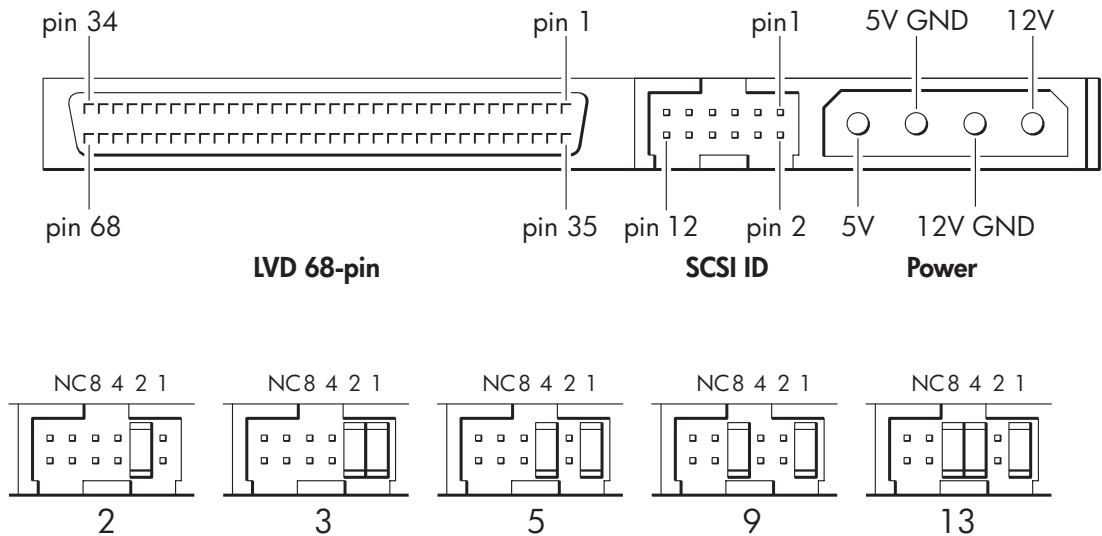
The following diagram shows jumper settings for a few example SCSI IDs:

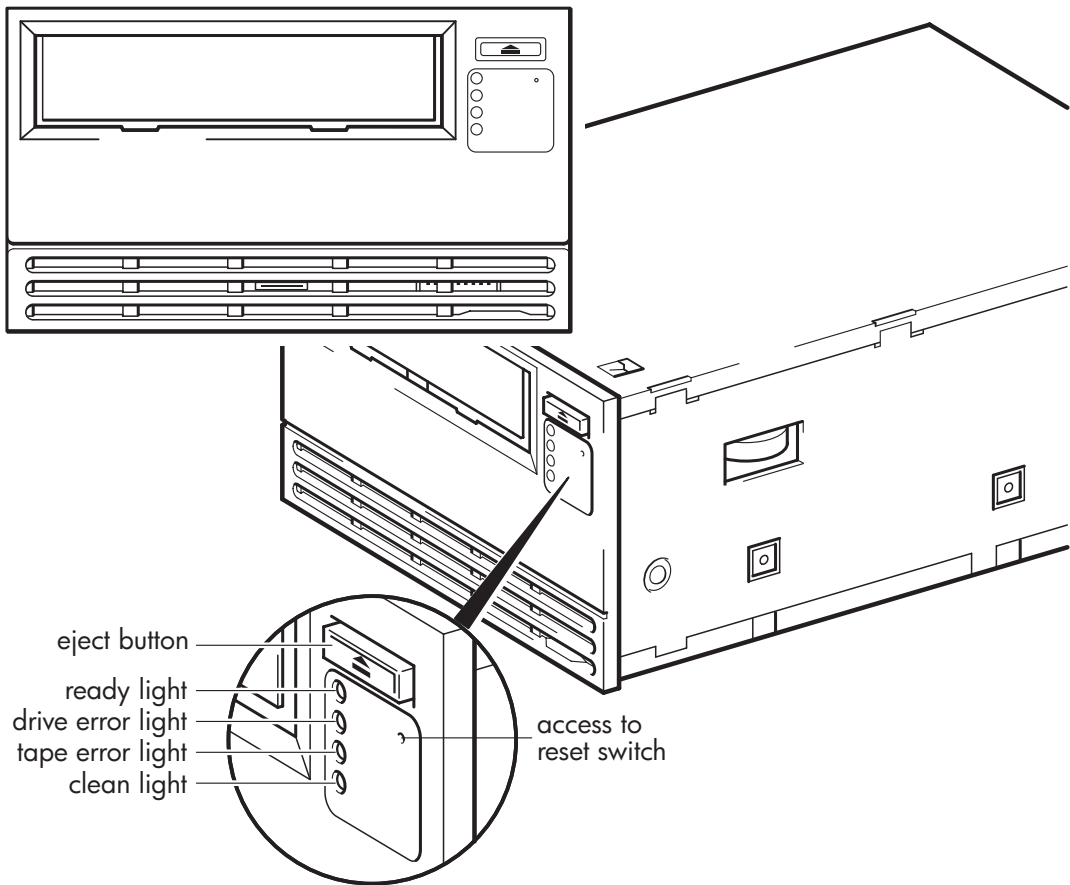
**Figure 2** Full-height drive

The emergency reset switch allows you to reset the drive without powering off the drive and computer, for example if the drive stops responding. Access to the switch is through a small hole. It can be activated by a thin object, such as the end of a straightened paper-clip.

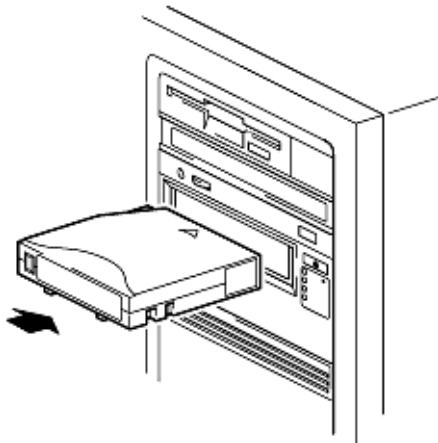
## Loading a cartridge

1. Insert the cartridge into the slot in front of the drive with the white arrow uppermost and facing the drive door.
2. Apply gentle pressure on the rear of the cartridge until the drive takes the cartridge and loads it.

Do not try to force the cartridge if it does not load properly. The drive will eject the cartridge after about 10 seconds so you can load it again.

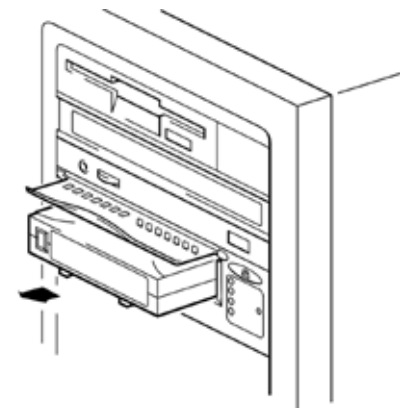
## Unloading a cartridge

1. Press the Eject button on the front panel. During the unload sequence the READY LED flashes green. The drive completes any task it is currently performing, rewinds the tape and ejects the cartridge. Once the tape has rewound, the eject cycle will take less than 13 seconds.
2. Remove the cartridge and store it in its plastic case in a cool, dry atmosphere.

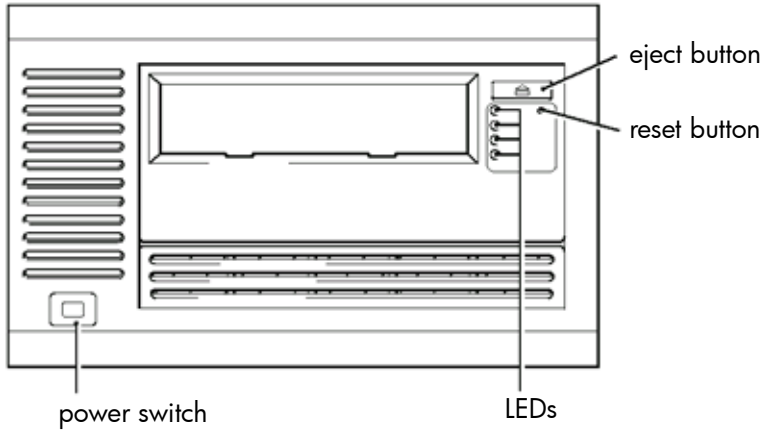
## Front panel features

The emergency reset switch allows you to reset the drive without powering off the drive and computer, for example if the drive stops responding. Access to the switch is through a small hole. It can be activated by a thin object, such as the end of a straightened paper-clip.

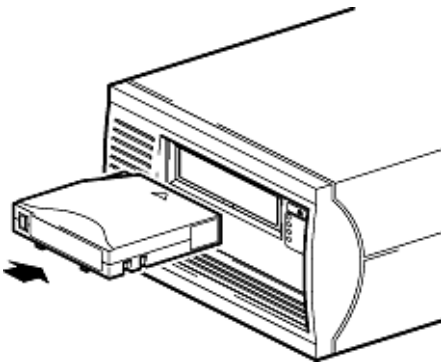
## Loading a cartridge

1. Insert the cartridge into the slot in front of the drive with the arrow uppermost and facing the drive door.
2. Apply gentle pressure on the rear of the cartridge until the drive takes the cartridge and loads it.

Do not try to force the cartridge if it does not load properly. The drive will eject the cartridge after about 10 seconds so you can load it again.

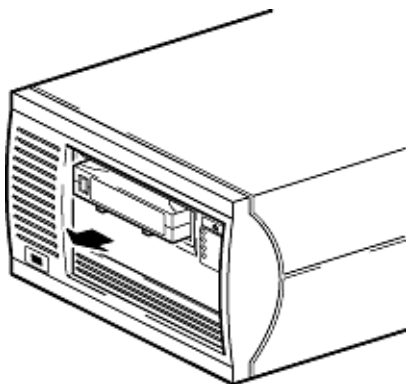
## Unloading a cartridge

1. Press the Eject button on the front panel.  
During the unload sequence the READY LED flashes green. The drive completes any task it is currently performing, winds the tape to the beginning and ejects the cartridge. Once the tape has rewound, the eject cycle will take less than 13 seconds.
2. Remove the cartridge and store it in its plastic case in a cool, dry atmosphere.

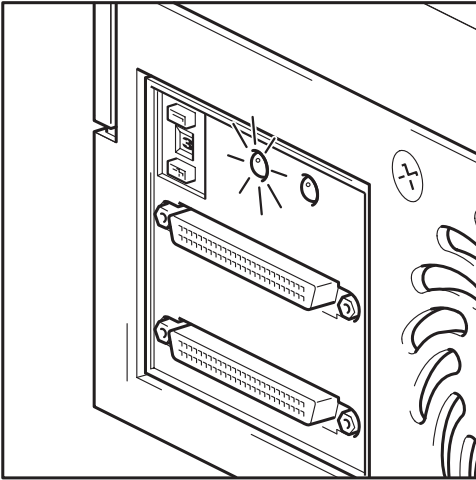
### **Act TERM** (termination active)

The rear panel has two additional LEDs as shown below.

- Off** The drive enclosure is not providing active termination (there is another device or terminator attached to the SCSI-OUT connector).
- On** The drive enclosure is providing active termination on the SCSI bus.

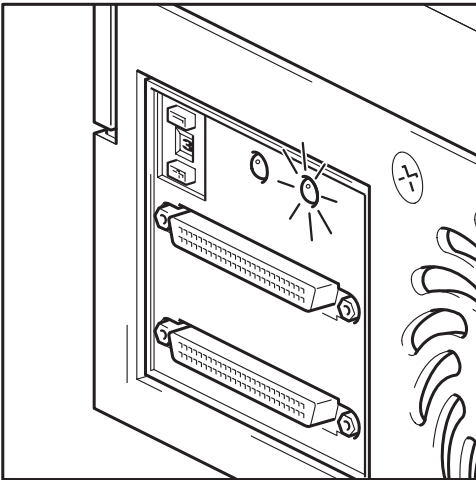
### **Fan/PWR Fault** (fault with the fan or power supply)

- Off** No fault has been detected.
- On** A fault has been detected with the fan or power supply. Call for support.

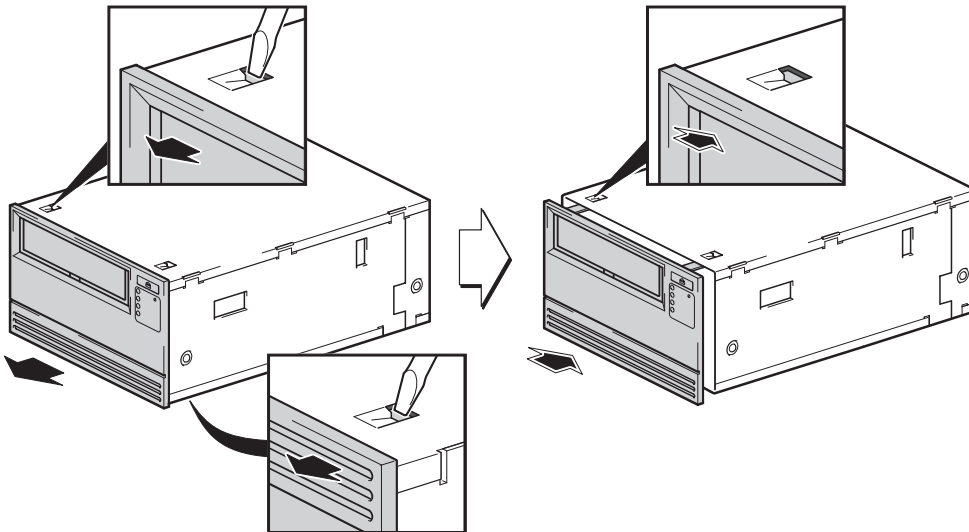
## Replacing the front panel on an full-height LTO Ultrium drive

1. Use the screwdriver to release the tabs at the top of the chassis and underneath.
2. Pull the front panel towards you and away from the drive.

To replace the panel, line up the four tabs with the chassis and push the panel firmly into place. There will be a slight click when the lugs are located in the chassis.

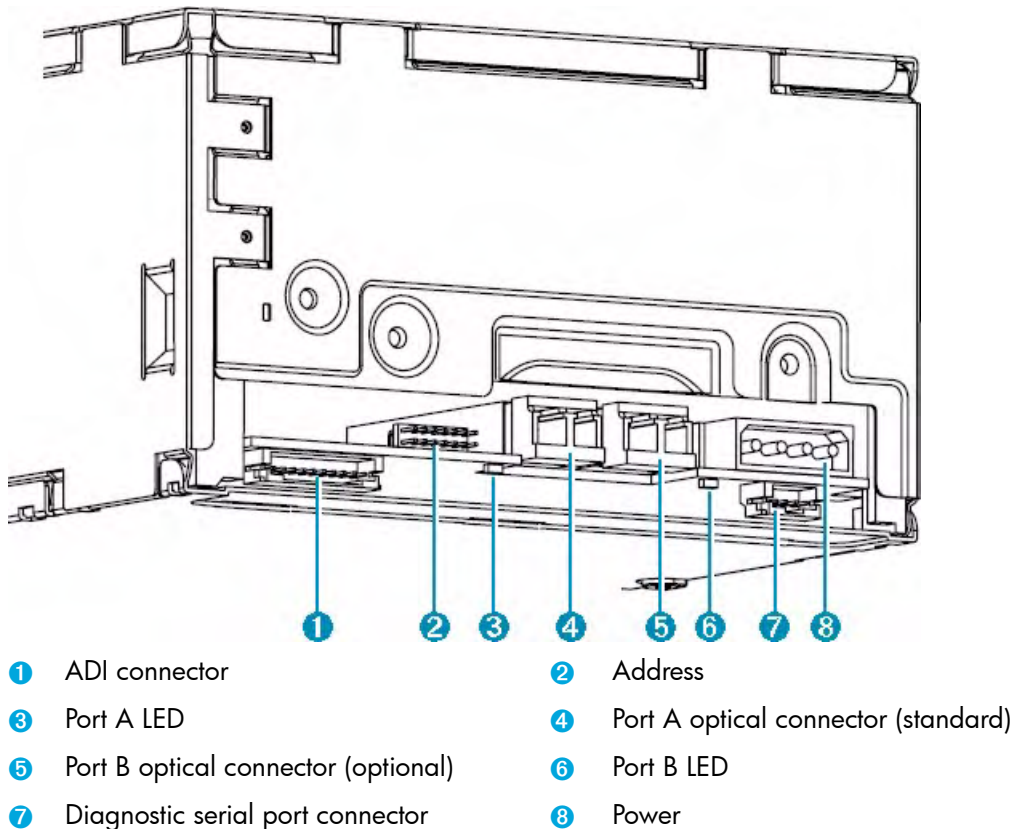
**Figure 3** Rear panel components for a Fibre Channel drive

- *Either:* Two SFP duplex-LC optical fibre connectors (only one might be connected)
- *Or:* A SCSI or SAS connector
- ACI/ADI connector (for libraries)
- Diagnostic serial port

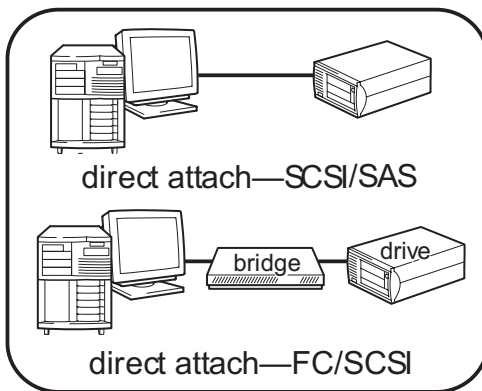
### Direct Attach

A SCSI tape array is directly attached to a single server via a SCSI link or a fibre channel/SCSI router.

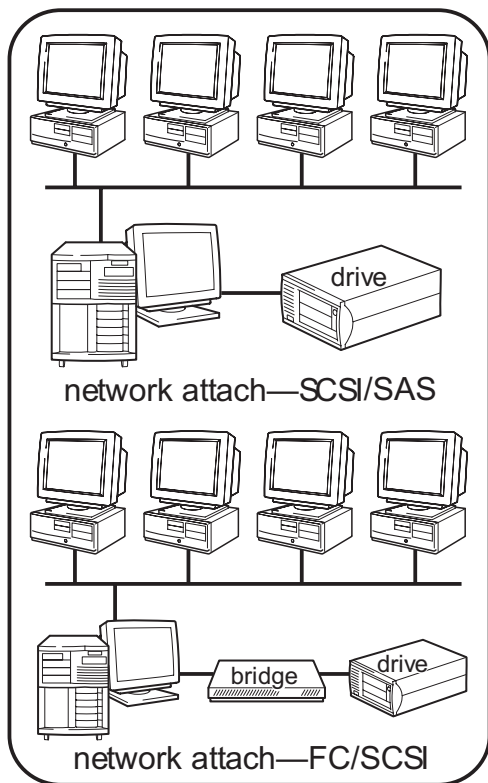
## Network Attach (LAN)

A SCSI or SAS tape array is directly attached to a network storage server that can be accessed by a number of clients or workstations. As with the direct attach model, the connection is via a SCSI or SAS link or fibre channel/SCSI router to the storage server.

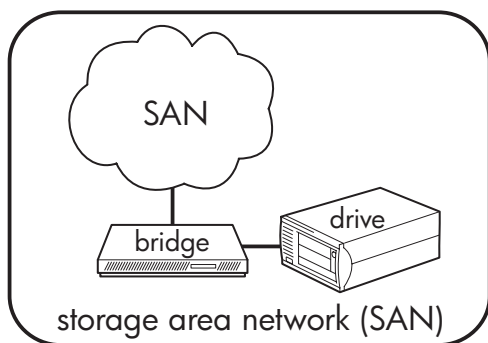
## Storage Area Network (SAN)

A SCSI tape array is attached to the SAN via a fibre channel/SCSI router. The array can be used to back up any device in the fibre channel fabric; in practise, the system administrator decides which devices will be able to see and access the array.

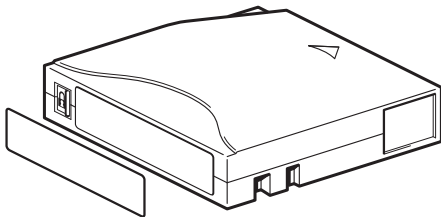
### Labeling cartridges

The label and write-protect switch are on the rear face of the cartridge, as illustrated.

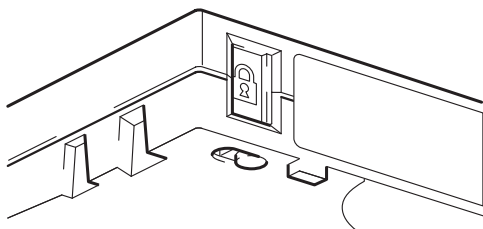
To write-protect a cartridge, slide the write-protect tab by the label area on the rear face of the cartridge to close the hole.

Note the padlock on the tab that indicates that the cartridge is protected.

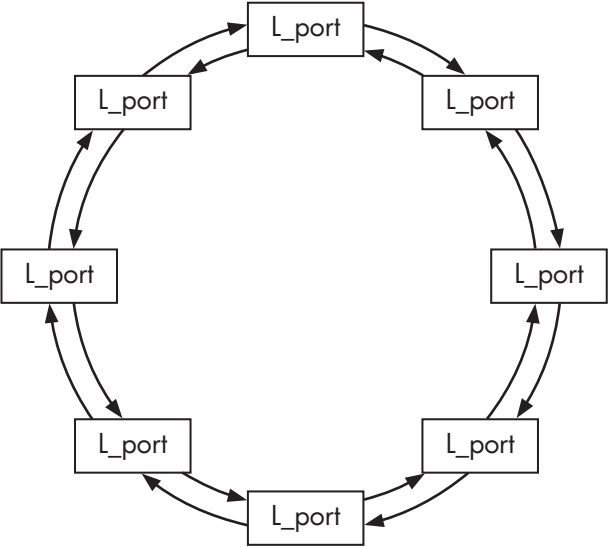
<b>AL_PA</b>	Arbitrated Loop Physical Address. A 1-byte value used in the arbitrated loop topology used to identify L_ports. This value will then also become the last byte of the address identifier for each public L_port on the loop. The AL_PA can be set through an ACI Set Drive Configuration command.
<b>ANSI</b>	American National Standards Institute, which sets standards for, amongst other things, Fibre Channel, SCSI and the safety of electrical devices.
<b>arbitrated loop</b>	One of the three Fibre Channel topologies. Up to 126 NL_ports and 1 FL_port, or 127 NL_ports, are configured in a unidirectional loop. Ports arbitrate for access to the loop based on their AL_PA. Ports with lower AL_PAs have higher priority than those with higher AL_PAs.

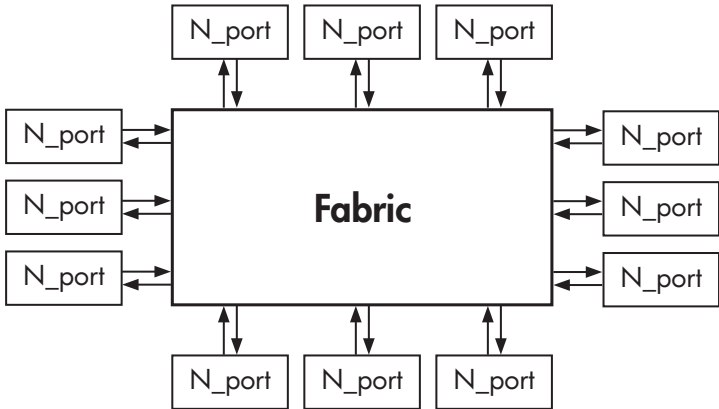
<b>ready-to-eject position</b>	A point at which a cartridge is held after an unload command is received by the drive (when Auto-Eject is not set) and the tape has be rewound and unthreaded. The drive will then wait at this point until it is commanded to eject the cartridge by the ACI Unload command
<b>SAN</b>	Storage Area Network. A dedicated, high-speed network that establishes a direct connection between storage elements and servers. The hardware that connects workstations and servers to storage devices in a SAN is referred to as a fabric. The SAN fabric enables any-server-to-any-storage device connectivity through the use of Fibre Channel switching technology.
<b>SFP</b>	Small Formfactor Pluggable transceiver. See <a href="#">transceiver</a> .
<b>switched fabric</b>	One of the three Fibre Channel topologies. An interconnected network of Fibre Channel host ports, device ports and switch ports. In the fabric topology, N_ports are connected to F_ports on a switch. The link is the two unidirectional fibres transmitting in opposite directions. Each fibre is attached to a transmitter of a port at one end and a receiver of another port at the other end. It is possible for fabric switches to be connected to support up to 16 million+ N_ports on a single network.

<pre> graph TD     subgraph Top         N1[N_port]         N2[N_port]         N3[N_port]     end     subgraph Bottom         N4[N_port]         N5[N_port]         N6[N_port]     end     subgraph Left         N7[N_port]         N8[N_port]         N9[N_port]     end     subgraph Right         N10[N_port]         N11[N_port]         N12[N_port]     end     Fabric[Fabric]     N1 &lt;--&gt; Fabric     N2 &lt;--&gt; Fabric     N3 &lt;--&gt; Fabric     N4 &lt;--&gt; Fabric     N5 &lt;--&gt; Fabric     N6 &lt;--&gt; Fabric     N7 &lt;--&gt; Fabric     N8 &lt;--&gt; Fabric     N9 &lt;--&gt; Fabric     N10 &lt;--&gt; Fabric     N11 &lt;--&gt; Fabric     N12 &lt;--&gt; Fabric </pre>
<b>TapeAlert</b>	A set of 64 flags is held in the TapeAlert log that indicate faults or predicted faults with the drive or the media. By reading this log, host software can inform the user of existing or impending conditions, and can, for example, advise the user to change the tape.
